Osage City Lake Restored with Mechanical Dredging

The dam impounding Osage City Lake was built in 1910. Over 100 years later in 2014, the dam has been reconstructed to protect its integrity and to slow the flow of water exiting the spillway, minimizing erosion of the streambanks downstream.

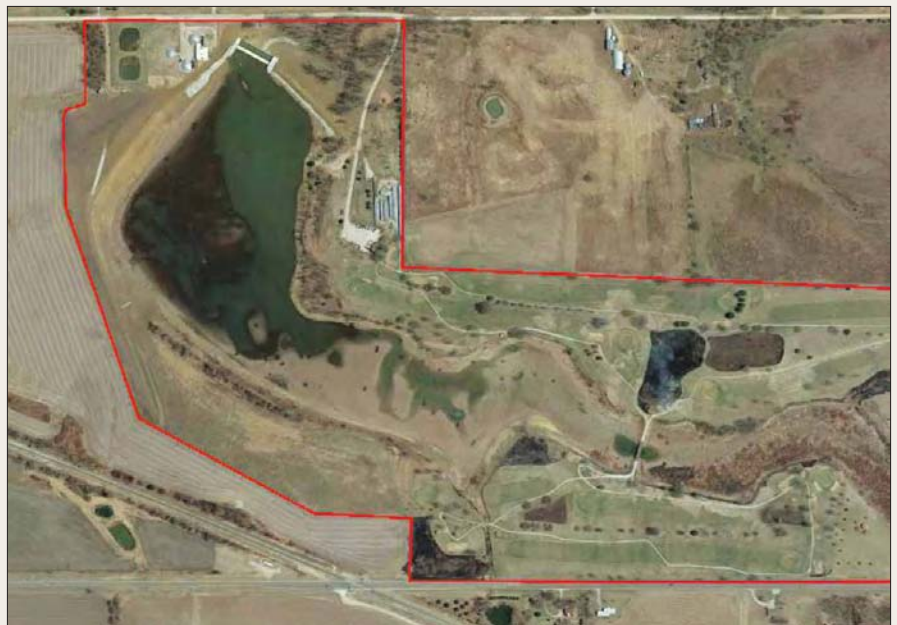
This aerial view of the Osage City Lake from Google Earth shows the nearly empty condition of the lake in March of 2014. The red boundary shows the approximate extent of the City of Osage City property. Much of the exposed lake bed shown in this photograph was dredged.

The lake has a capacity of 405 acre-feet. Before the dredging started, it was estimated that 143 acre-feet of sediment had settled into the lake, a reduction of storage capacity of 35 percent. The average thickness of the sediment was approximately 2.9 feet, and ranged from as little as 0.9 feet close to the dam, to as much as 5.7 feet in the middle to upper part of the lake, where the inflow experiences a significant decrease in flow velocity and allows the sediment to settle. The lake's drainage area is approximately 3,030 acres, which has contributed an average of approximately 2.5 acre-feet of sediment per year since 1954.

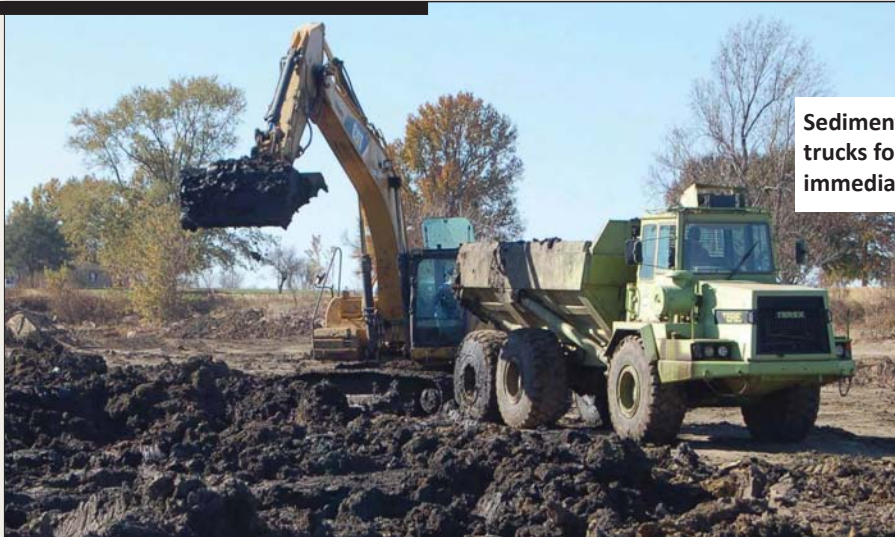
Sediment scraped from the lake bed is loaded onto trucks for transport to the staging area located immediately west of the Osage City Lake.

The process that was found to work best was to use two excavators on the lake bed to scoop out the sediment. The

buckets that were used were not like typical buckets with teeth that one might find on backhoes. The digging edge of the buckets was gently curved, like the edge of a person's hand scooping sand on a beach. This design allowed the buckets to glide over the original rock of the lake bed, and remove only the deposited sediment, without ripping out any extra rock.

Two or three large dump trucks to haul the excavated material would first drive under a sprinkler system to wet the dumping bed of the truck. It was

found early in the project that some of the excavated sediment was very sticky, especially on hot, dry, smooth metal. Wetting it first helped more of the loaded material slide out of the dumping truckbed. After being wetted, the trucks would drive down to the active excavation area on the lake bed and be loaded. Once loaded, the trucks drove out of the lake to a staging area west of the lake where the excavated sediment was unloaded. The trucks would return to the sprinkler and repeat the process.

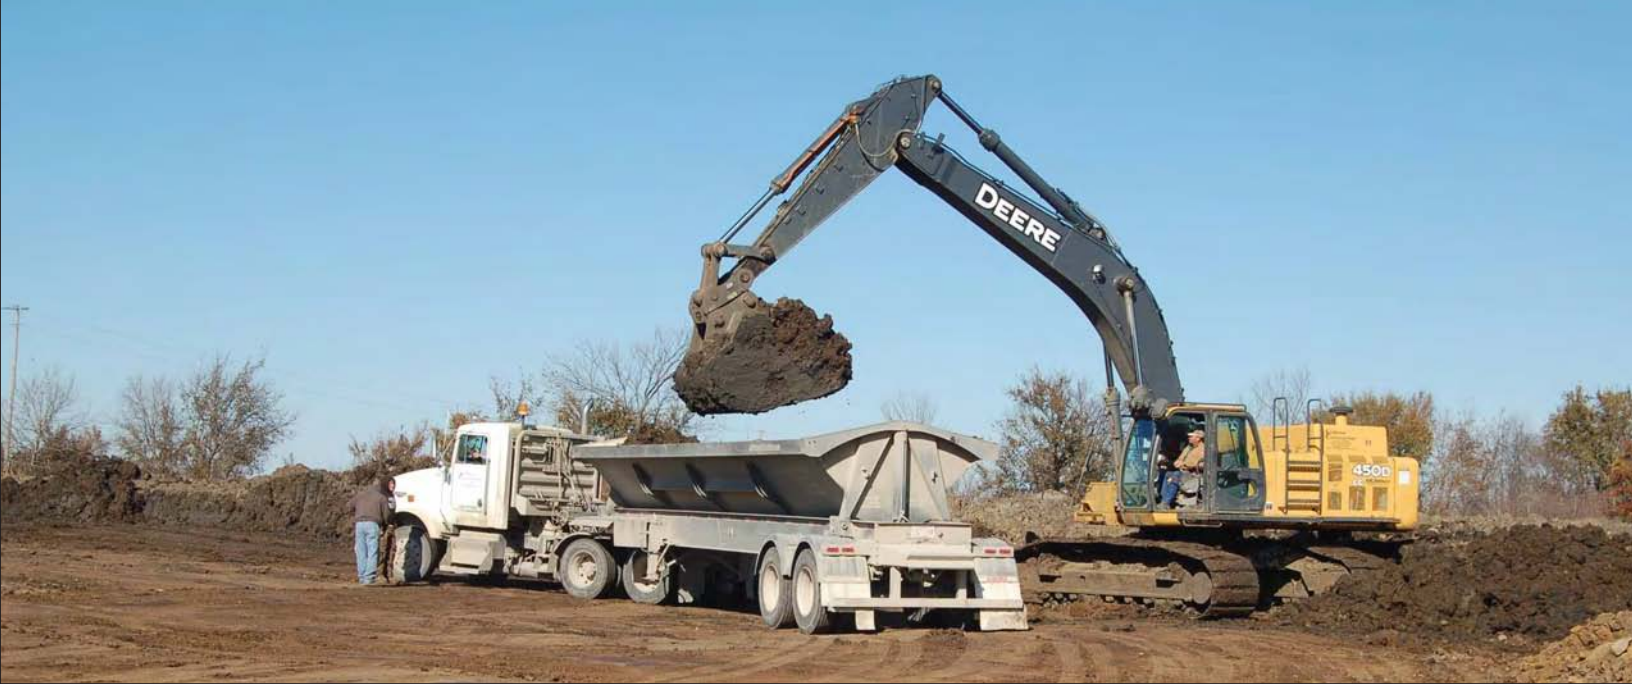
After the dredged material is dumped at the staging area, it is turned and allowed to partially dry. After completing the drying process, it is re-loaded onto trucks suitable for hauling on public roads.

At the staging area, a loader turns the dumped sediment to accelerate evaporation of any water, until one of the 8 to 10 trucks in the "highway group" would arrive for loading. These trucks are loaded with partially dried sediment and hauled it to the disposal area located 5 miles south and 2 miles east of the Osage City Lake, adjacent to US Army Corps of Engineers land at Melvern Lake. The disposal site is in an abandoned quarry that was purchased by the Kansas Department of Wildlife, Parks and Tourism in 2008. This site is currently used for walk-in hunting and fishing. The sediment is stacked on rock, and not in the deepest part of the quarry where fishing occurs. The dredged material will be contained in such a way that it will not be allowed to erode and enter any streams, ditches, the quarry lake, or Melvern Lake. The dredged material is expected to allow the growth of vegetation suitable for wildlife habitat.
